Engineering Note: EN0056 - ORBA2 Installation and Calibration

Summary: ORBA2 - Installation and Calibration of Hydro-Probe Orbiter Ceramic Arm

Products affected: Hydro-Probe Orbiter / Hydro-Probe Orbiter II

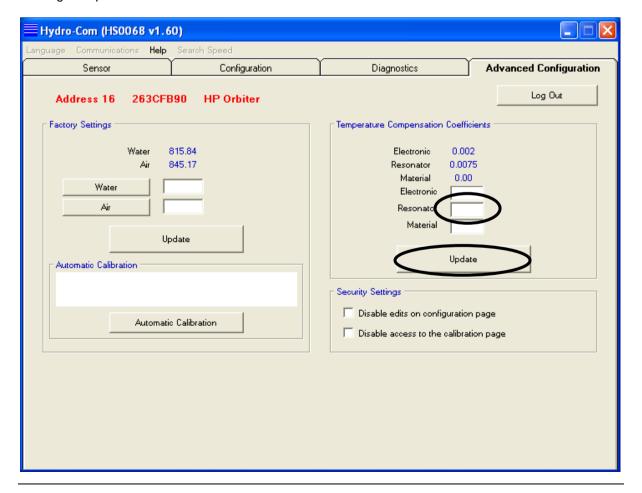
This is done by typing the new value into the Electronics and Resonator boxes shown below, and then clicking on Update.

Product	Software Version	New Values			
		Electronics Frequency	Electronics Amplitude	Resonator Frequency	Resonator Amplitude
Orbiter I	HS0063	No change	N/A	+0.015	N/A
Orbiter II	HS0089	-0.0035	-0.15	+0.015	+0.036

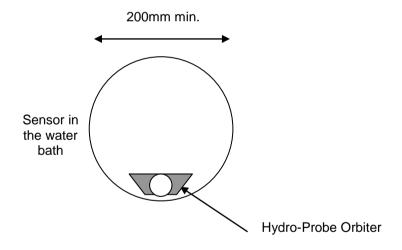
Figure 1: Water Calibration

The water reading should be carried out in a bucket filled with a clean brine solution. This solution should be made up from water with 0.5% by weight of salt (e.g. 10 litres of water to be mixed with 50gm of salt). The level of water needs to cover the ceramic face-plate, and at least 200mm of water is needed in front of the ceramic. It is suggested that the sensor is held in the bucket offset to one side with the face towards the centre of the bucket (see Figure 1), hence the measurement is carried out with a full bucket of water in front. Press the Water button. The software will make a new water measurement.

Minimum water depth 200mm

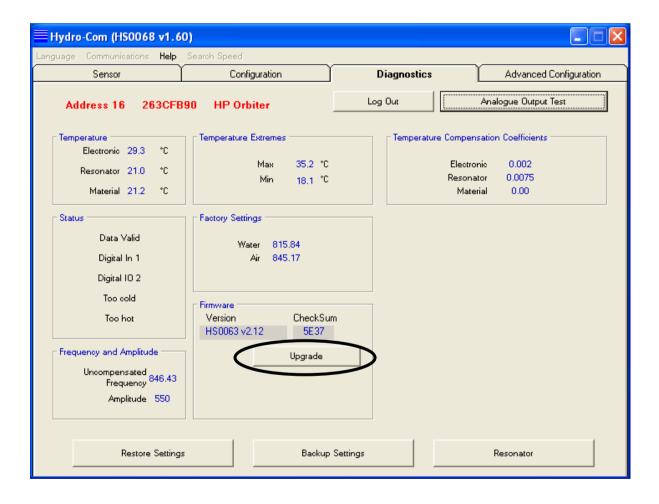
The firmware can then be upgraded using Hydro-Com. From the Diagnostics tab, press the Upgrade button as shown then select the Firmware Upgrade file from the location where it was saved. The Hydro-Probe Orbiter will then be upgraded. Do not disconnect the sensor during the upgrade process.

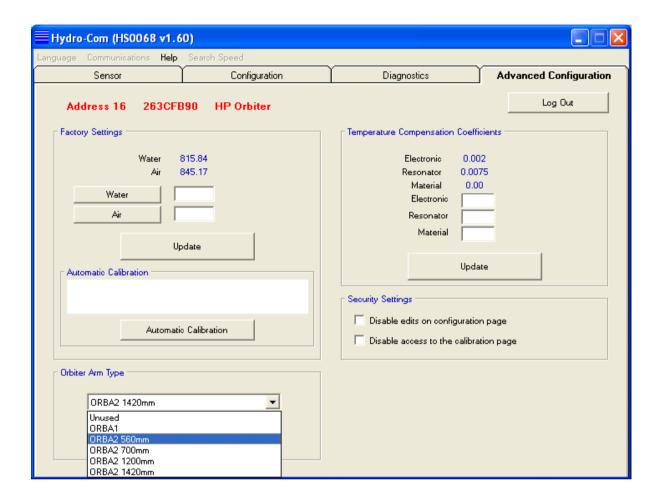
When swapping the Arm, it is important that the head unit knows what type of arm is fitted. This is done via an option in the Advanced Configuration tab of Hydro-Com. This will allow you to select which type of Orbiter arm you have installed in the Orbiter.

Select the type of Orbiter Arm that you have installed and then press the Write button. The Arm information will be saved into the Orbiter and the parameters that control the Auto-Cal facility will be adjusted accordingly. Thereafter the Auto-Cal facility will correctly Auto-Cal the Orbiter when instructed.
